# **Pentium<sup>®</sup> II Processor Specification Update**

Release Date: December 1998

Order Number: 243337-021

The Pentium<sup>®</sup> II processor may contain design defects or errors known as errata which may cause the product to deviate from published specifications. Current characterized errata are documented in this Specification Update.

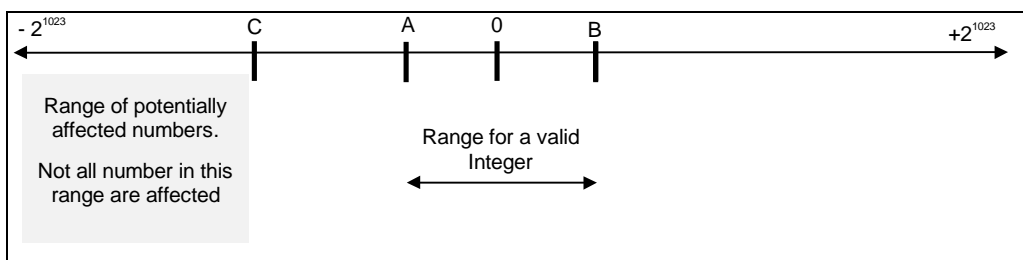
**IMPLICATION:** Erroneous operation results when the operand is so large that it will not fit into the target data size. The operands affected by this erratum are significantly outside (by a factor of 3X) the range that can be, correctly, converted to an integer value. The figure below and corresponding table identifies the normal range of integer numbers (between A and B) and the starting point of the operands affected by this erratum. Discrete failing operands will be present in the range between point C and the maximum negative number that can be represented by the processor ( $-2^{1023}$  in double precision format). Note 2 below gives a qualitative description of the nature of the discrete failing values. Software that does not rely on the Invalid Operation exception flag being set and signaled by either an exception OR by software polling is not impacted by this erratum.

16-bit Operation	A	B	C
	-32,768.0	+32,767.0	< -98304.0
32-bit Operation	A	B	C
	-2,147,483,648.0	+2,147,483,647.0	< -6,442,450,944.0

**WORKAROUND:** Any of two software workarounds will avoid occurrence of this erratum:

1. Range checking performed prior to execution of the FIST[P] instruction will prevent the overflow condition from occurring, and may already be implemented as a coding style.
2. Software can use the presence of MAXNEG in the result integer to indicate that an out of range conversion may have occurred.

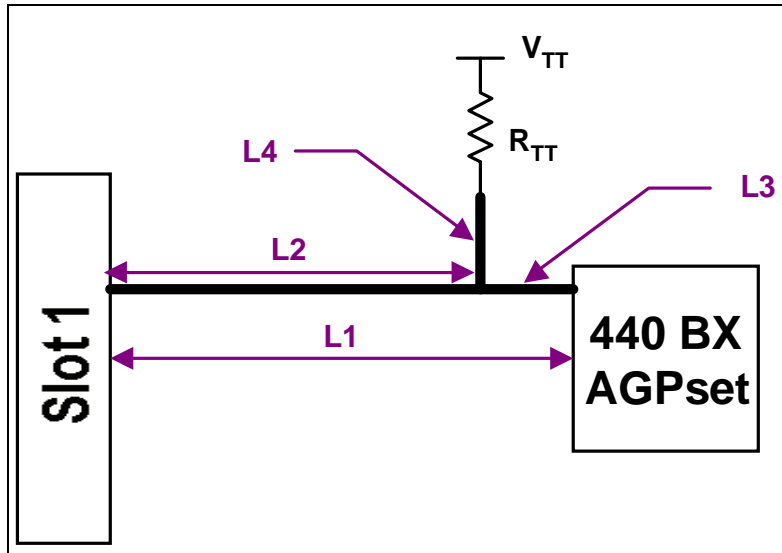
Figure 1. UP Dual Ended Termination (DET)

For UP-DET topologies (see Figure 1), the trace length L1 must be between 1.5" to 4.5" while using a 56Ω termination resistor.

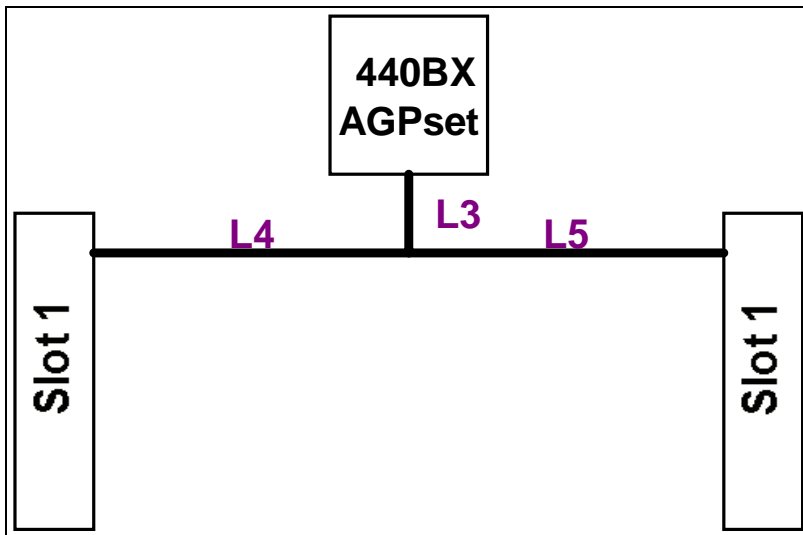
Figure 2. DP Dual Ended Termination (DET)

For DP topologies (see Figure 2) installed with a processor and a termination card, L4 + L3 or L5 + L3 must be less than or equal to 4.5". Additionally, for DP platforms with one processor installed, the termination card should be placed in the longer leg.

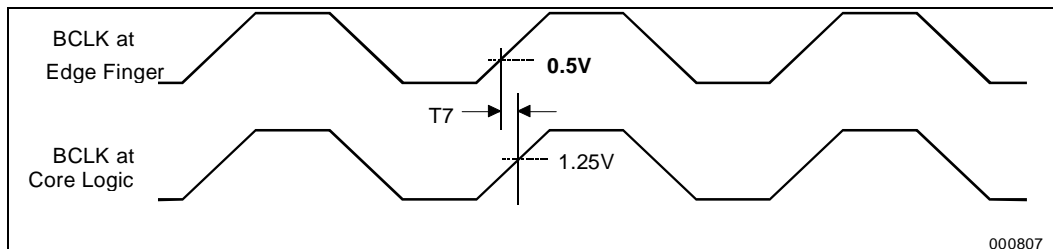
**Figure 6. BCLK to Core Logic Offset**

In Figure 6 of the *Pentium® II Processor at 233 MHz, 266 MHz, 300 MHz, and 333 MHz* datasheet, the following changes should be made:

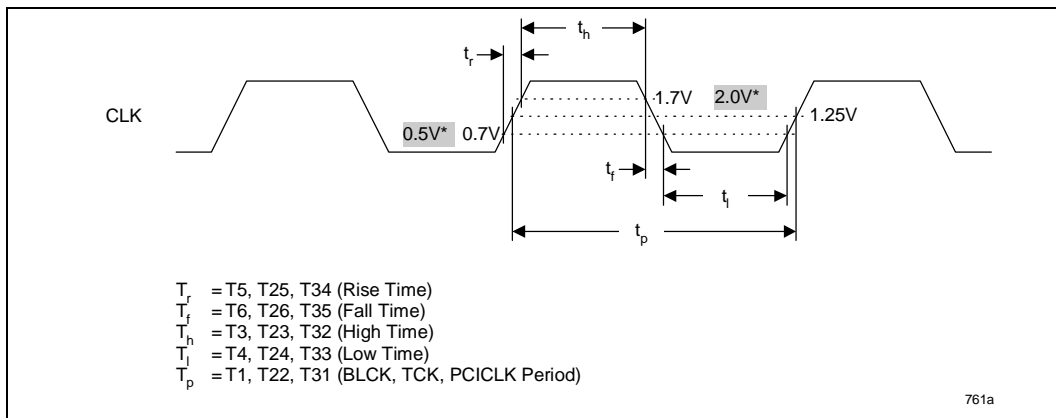
**Figure 7. BCLK\*, PICCLK, and TCK Generic Clock Waveform**

In Figure 7 of the *Pentium® II Processor at 233 MHz, 266 MHz, 300 MHz, and 333 MHz* datasheet, the following changes should be made:
